Manhole Inspection Summary

Manhole # S11MM_003MH

Insp Date: **7/13/09 3:46 PM**

Location Address: **2931 WINDSOR AVE**

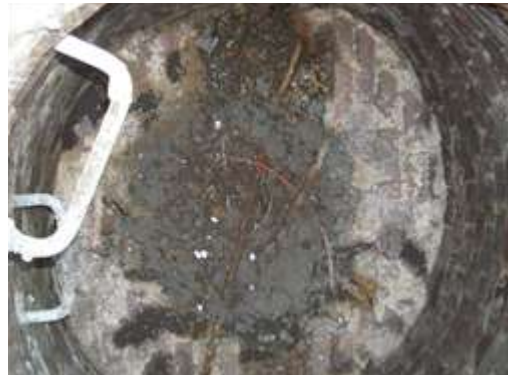
Top View

DEBRIS ON CHANNEL

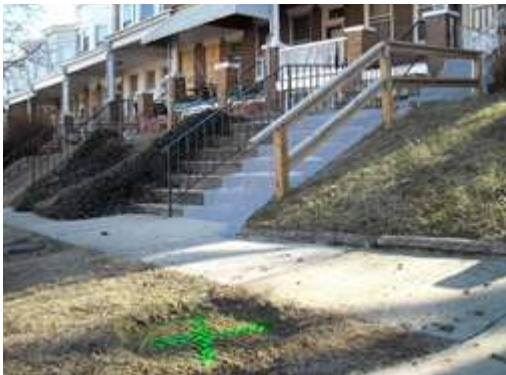
LOCATED AND EXPOSED

EXPOSED IN GROUND

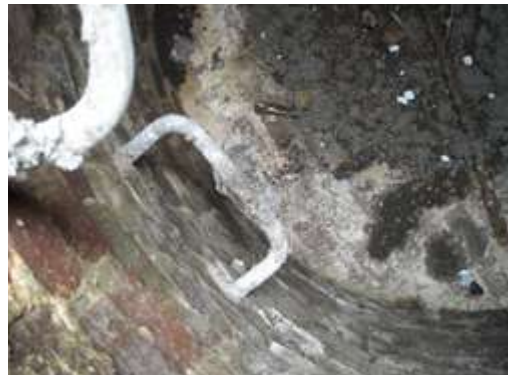
Defect 2

☒ **Evidence Of Surcharge** Depth: **1.5** (ft.) ☐ Active Surcharge Present

EVIDENCE OF SURCHARGE ON
BOTTOM STEP

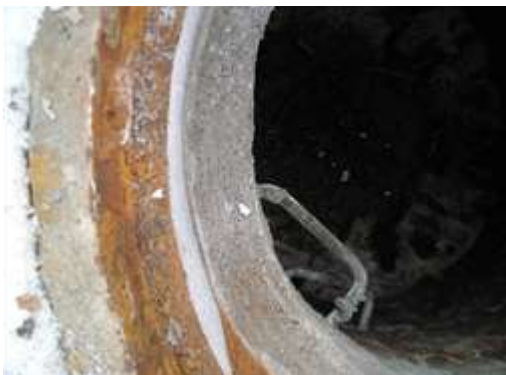
Defect 1

Offset: **2** (in.)

2" FRAME ADJUSTMENT
